**Appendix D: Trail Assessment**

To: Wehle Core Team Members  
From: Casey Holzworth  
Re: Trail Assessment Site Visit – Wehle State Park

A field evaluation of the Robert G. Wehle State Park trail system was conducted on April 20, 2010 by OPRHP staff members Casey Holzworth, Dan Heneka, John Shultz and Bob Smolka. During this evaluation, staff walked sections of the trails that were under evaluation for closure or relocation and assessed the need to re-route or close trails. In addition, sections of trails that had been identified as “wet areas,” or as being located in NWI wetlands, were field-checked.

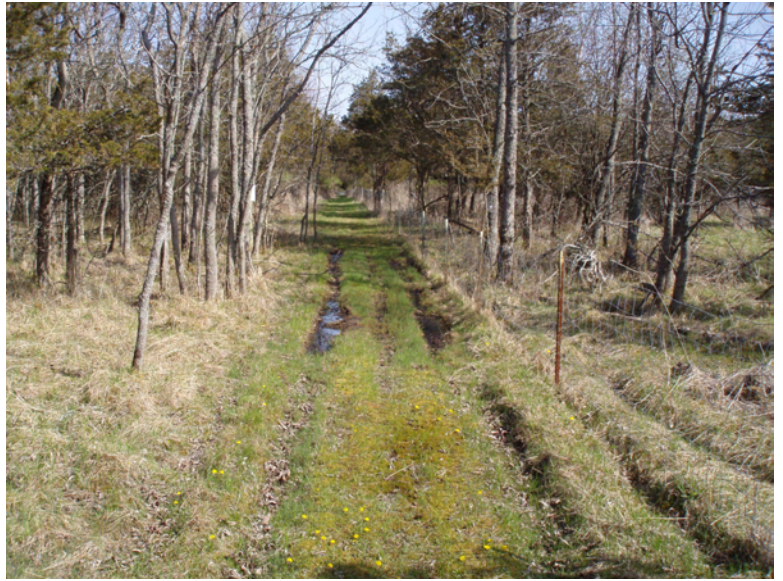
1. Dancing Gypsy – Field inspection found a roughly 50' wetland crossing with areas of the trail completely submerged. This trail is recommended for closure due to trail planning considerations (two trails, same name and destination). The presence of this wetland crossing supports that decision.

Regulated by: Army Corps

Recommended action: Trail removal

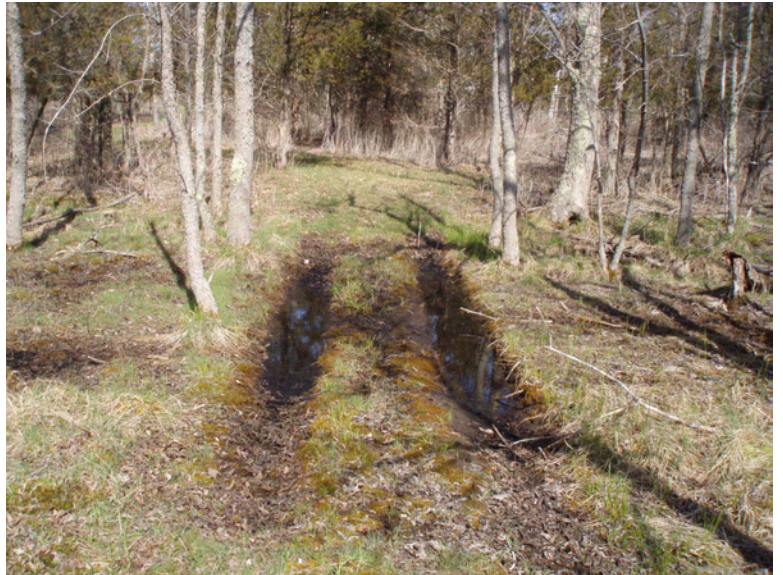
6. Knickerbocker – This site was confirmed as a wetland crossing. The crossing is narrow (15-20') and there did not appear to be an easy re-route around the wetland. The trail was still passable in the middle.

Regulated by: Army Corps

Recommended action: Boardwalk

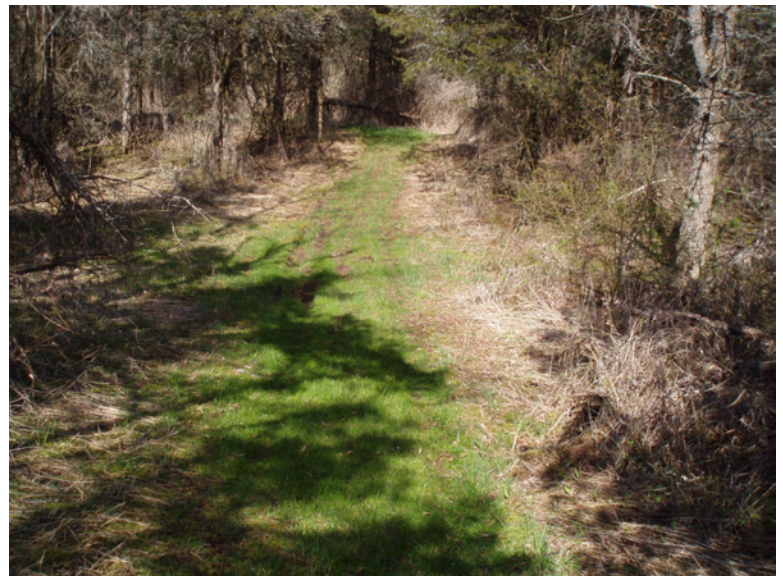
7. Dancing Gypsy – The area marked as wet at the northern limits of the trail was not very wet upon inspection. Clay-based soils may eventually become wetland but plant community did not show full wetland characteristics. Area was soft but no surface water was present.

Regulated by: None

Recommended action: None

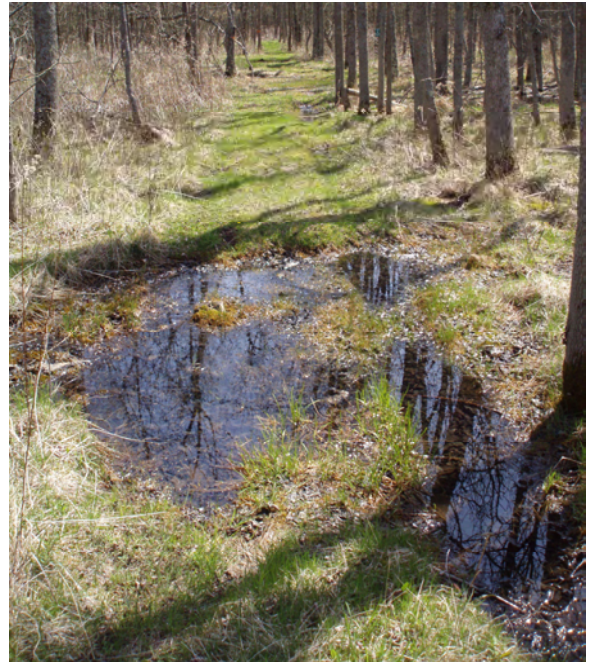
8. Marksmen – The location of a wet spot indicates an area of compaction and rutting that has caused relatively deep pools of standing water (approx. 40 ft. long), however, the trail in this area passes through approximately 150 ft. of wetlands that are currently passable.

Regulated by: Army Corps

Recommended action: Multiple Boardwalks or re-route

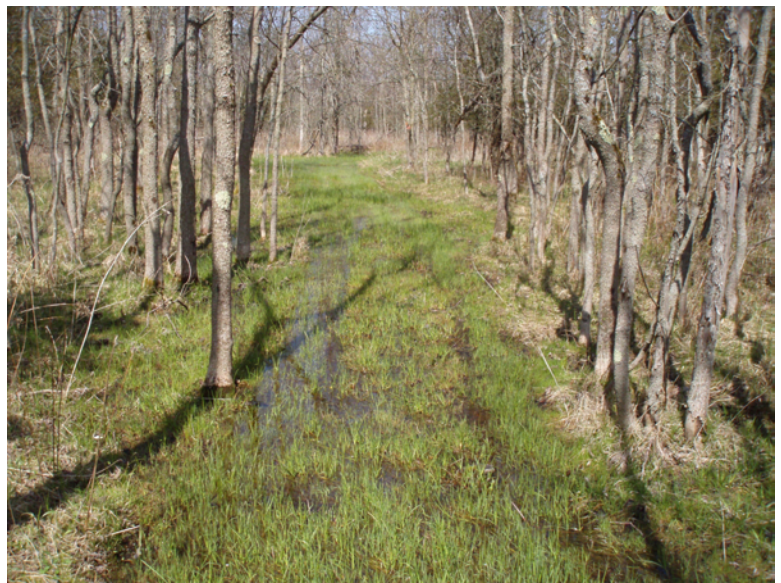
9. Jungle Cut-off – A culvert to the right of this picture, under the north-south portion of the Jungle Trail, connects this wetland area to the large wetland complex extending across military road and beyond the park boundary. This wet area, measuring approximately 60 feet, is only passable in the driest of times.

Regulated by: Army Corps and DEC

Recommended action: Trail removal

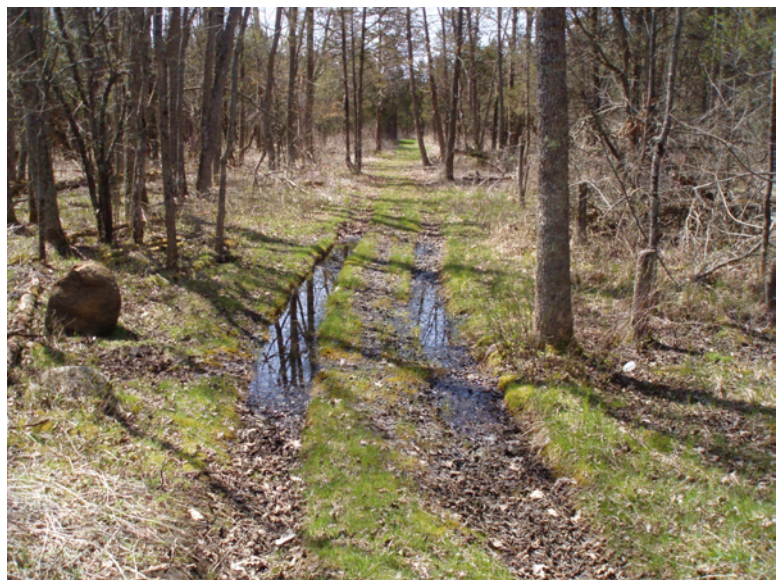
10. Snakefoot – 1000 feet south of the intersection with Marksman/Park Road field inspection found approximately 30 feet of impounded wet area through larger wetland crossing.

Regulated by: Army Corps

Recommended action: Boardwalk or Trail re-route

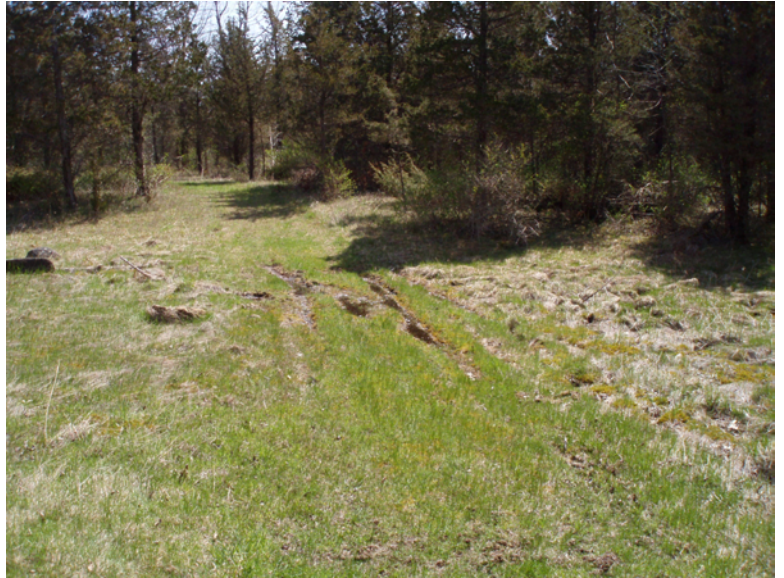
11. Bobolink – Approximately 40 ft. wetland crossing with an approximately 20 ft. surface water crossing. Wetland does not extend far to the north.

Regulated by: Army Corps

Recommended action: Boardwalk or Trail re-route

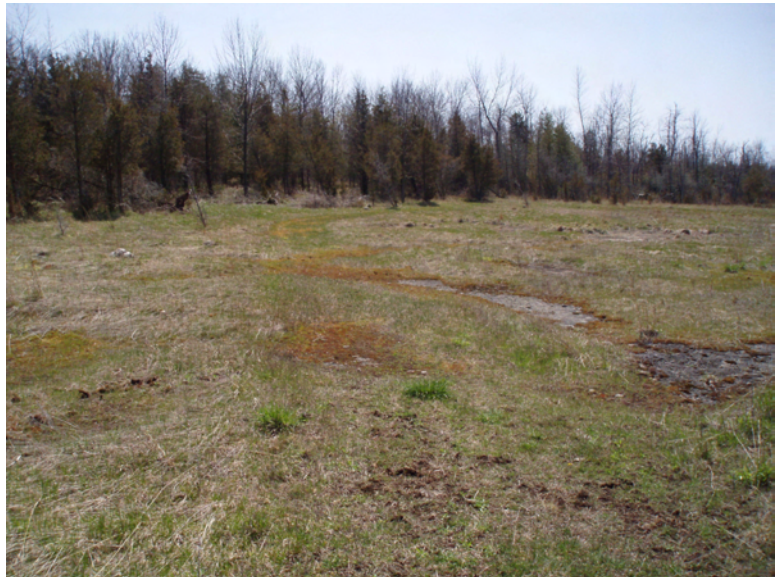
12. Bobolink – Portion of trail through sensitive alvar area. Alvar does not extend far to the north (left) (25') but does extend far to the south (right) (450'+). This trail appears to be on the edge of the alvar area. Moving the trail any further out of the area would not provide the educational opportunity that this crossing provides. The current location does a reasonably good job of limiting travel to the outskirts of the area.  
Recommendation: No re-route

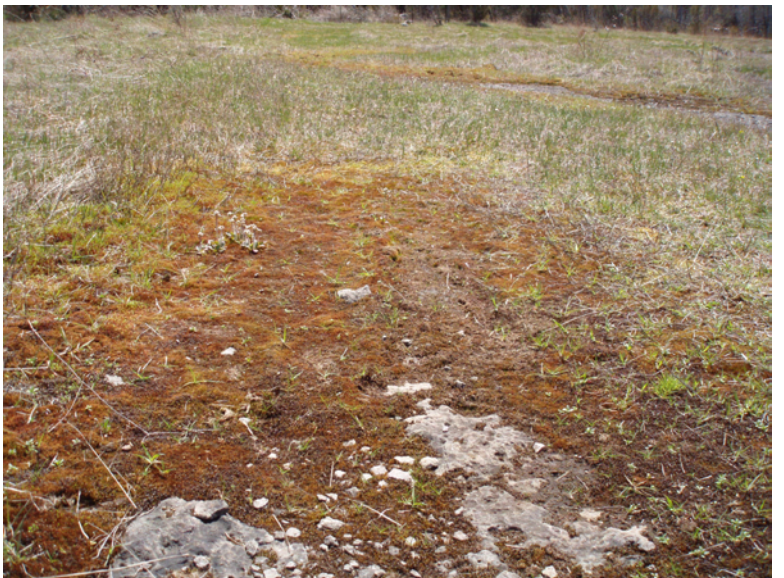
12. Bobolink – Photo shows close-up of trail through sensitive alvar area. Although there is certainly some damage to the alvar within the path of the trail, the trail is not devoid of alvar vegetation and has not been severely eroded.

Recommendation: Placement of large stones as a border to provide for a more clearly defined trail to keep visitors and equipment from unnecessarily leaving the trail.

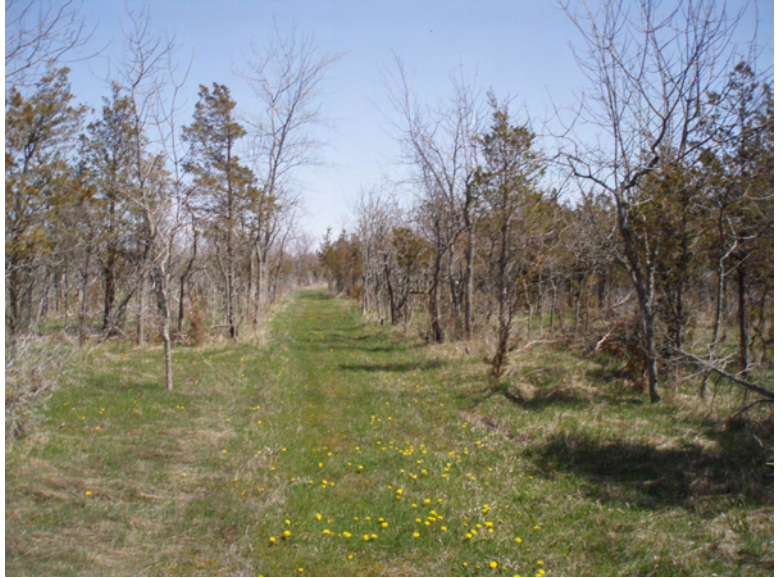
13. Huckleberry – Photo shows an area of trail through pavement barrens just east of intersection with un-named trail headed south. Un-named trail to the south (14) was planned to become the new alignment of Huckleberry and this portion of Huckleberry was to be closed. The un-named trail (14) appears to travel along a relatively clear edge of the pavement barrens, which extends to the north of the trail while Huckleberry appears to traverse directly through the barrens, each providing a different experience of the barrens. Recommendation: Further evaluation

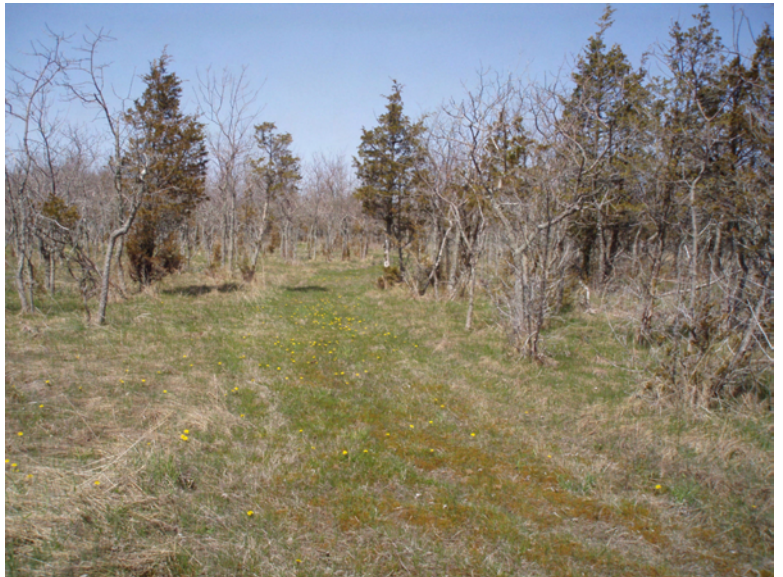
15. Un-named trail headed north from Huckleberry Trail. This trail, too, goes through the middle of pavement barrens. The trail also crosses a wetland just south of the intersection with the other un-named trail that connects to the utility access road. No wetlands were identified on the second un-named trail (4) or the nearby Midge trail suggesting that the wetland may be small in nature and that a re-route may be possible to avoid wetlands.

Regulated by: Army Corps

Recommended action: Boardwalk or Trail re-route
